## **Leak Detection for Potable Water Lines at Fort Hood**

Final Report on Project AR-F-313 for FY05

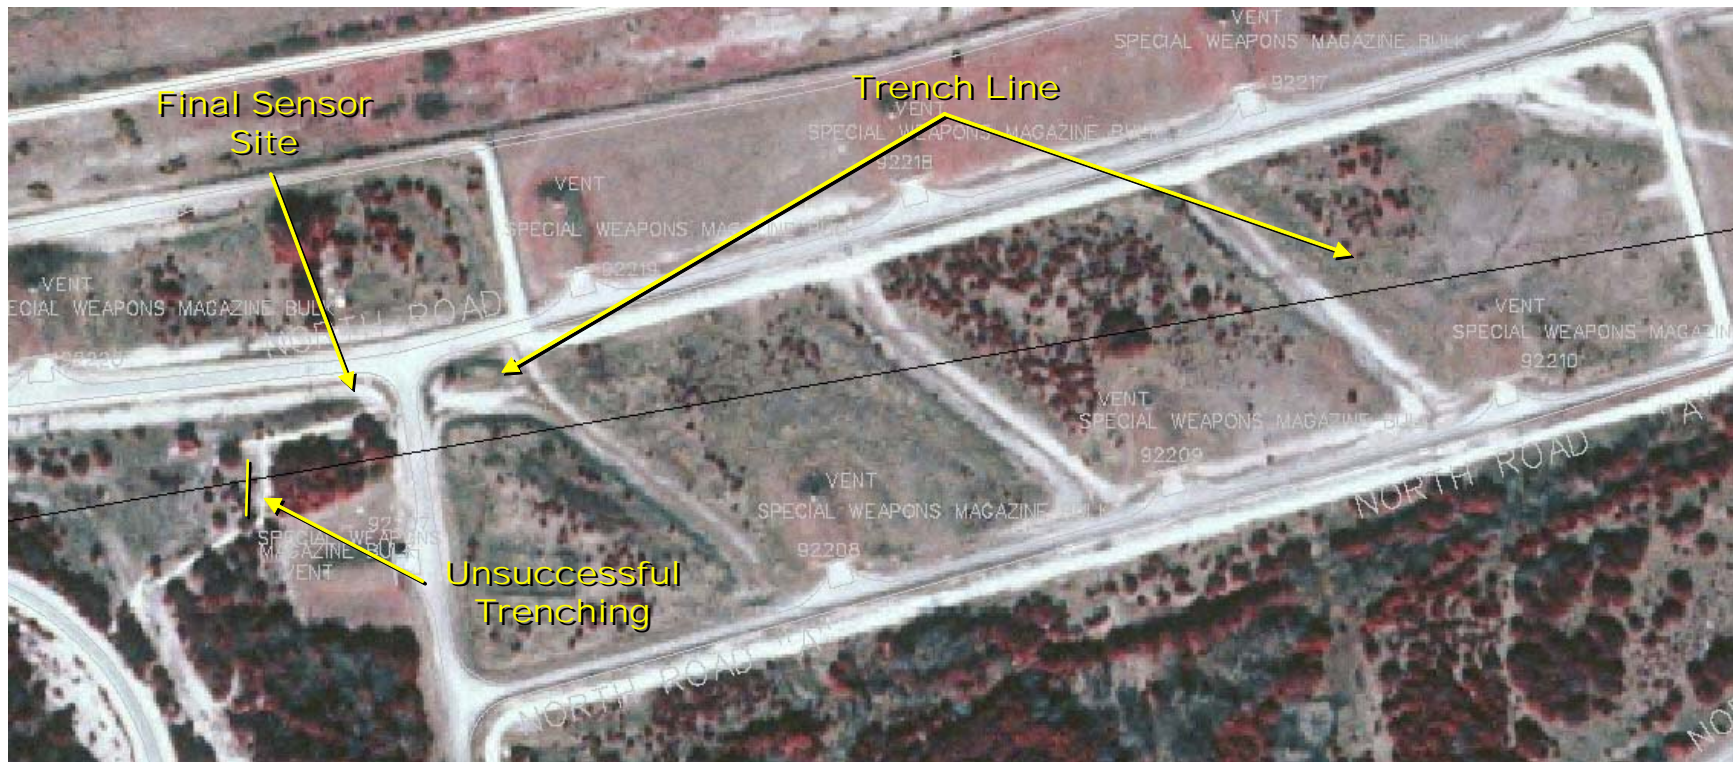
Figure 1. Showing how the false color multi-spectral maps reveal the actual route of the pipeline. Also showing how the actual pipeline route (light gray line) is different from the GIS map indicated route (black line).

- Obtain good mapping information and a means of easily tracing pipes through the ground. Pipeline maps are sometimes in error for a variety of reasons ranging from poor surveying to field repairs. The GIS maps at Fort Hood were for the most part quite accurate, but as explained in Chapter 3, problems were encountered in locating five sensors. The use

of multi-spectral maps made it possible to find trench lines that marked the true route of the missing pipelines (see Figure 1). Also, the use of radio frequency (RF) pipe location equipment, such as that shown in the foreground bottom right in Figure 2, proved invaluable.

The Public Works GIS branch was able to overlay the necessary multi-spectral maps on the contractor's electronic potable water pipeline maps of Fort Hood, thus allowing the contractors free access to the field at any desired location or degree of magnification. In addition, borrowed pipe location equipment (see Figure 2) allowed a pipeline's route to be traced by inducing an RF carrier into the metal line. Contractors traveled to each of the newly revealed trench lines, confirmed the presence of the pipeline with a magnetometer, and placed the RF transmitter over the pipe. Then, by simply walking with the RF receiver, the actual route of the pipeline could be traced through heavily wooded areas. Figure 1, Figure 6, and Figure 7 show the errors discovered in the GIS maps for five pipelines. In some cases, it was found that the actual pipeline route was more than 500 ft from where the GIS maps placed it. In 2 days of work,

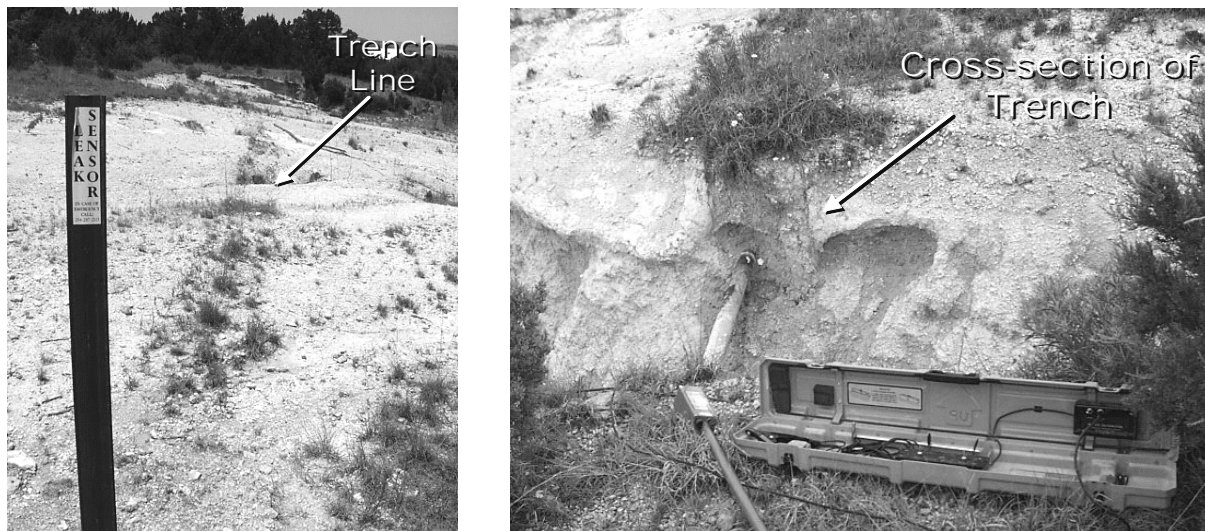
Figure 2. (Left) Showing how vegetation can reveal a trench line. (Right) Showing the backfill that causes different vegetation growth, as well as an RF pipeline location instrument.

The next several weeks involved gaining access to three secure areas and with locating the true route of the potable water lines in five locations. A breakthrough occurred when a Fort Hood naturalist brought into the field false-color multi-spectral maps of the vegetation on the installation, which helped him identify tree species. At one proposed sensor location, the map also showed the actual trench line for the pipeline, due to a difference between vegetation over the trench and next to the trench. The actual pale trench line can be seen in Figure 1, while the reason for the trench line growing different vegetation from its surroundings can be seen in Figure 2.

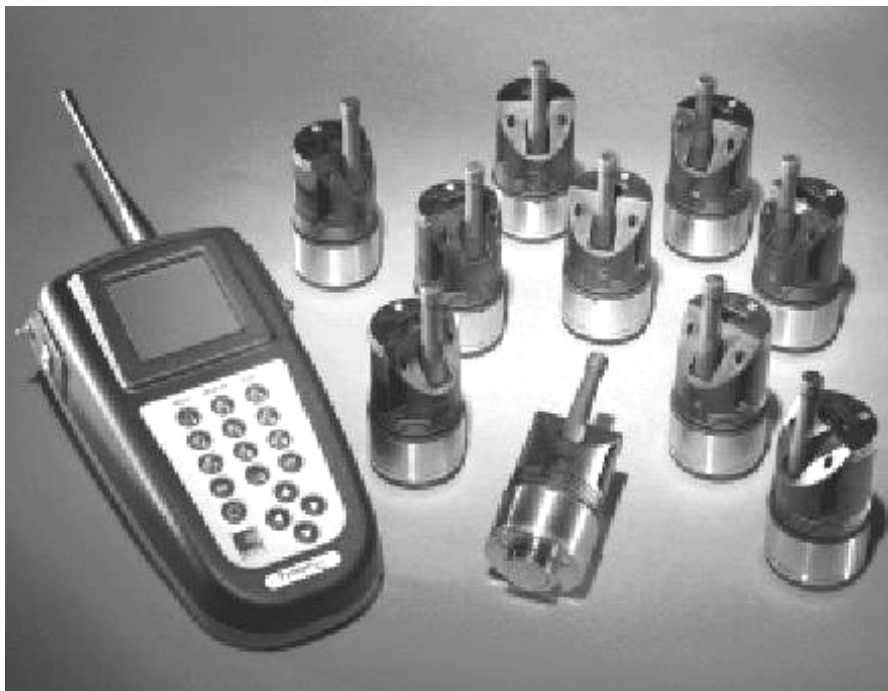
Figure 3. Showing 10 PermaLog leak sensors with a Patroller data retrieval unit.

Information is retrieved from the PermaLog sensors using a special radio receiver called a Patroller. This device is taken by vehicle into the vicinity of the PermaLogs, and their acoustic leak data are retrieved automatically. The retrieval takes place quickly; at West Fort Hood, the drive takes only 45 minutes, and vehicle speed limits rather than any technological issue were primarily responsible for the time expended.

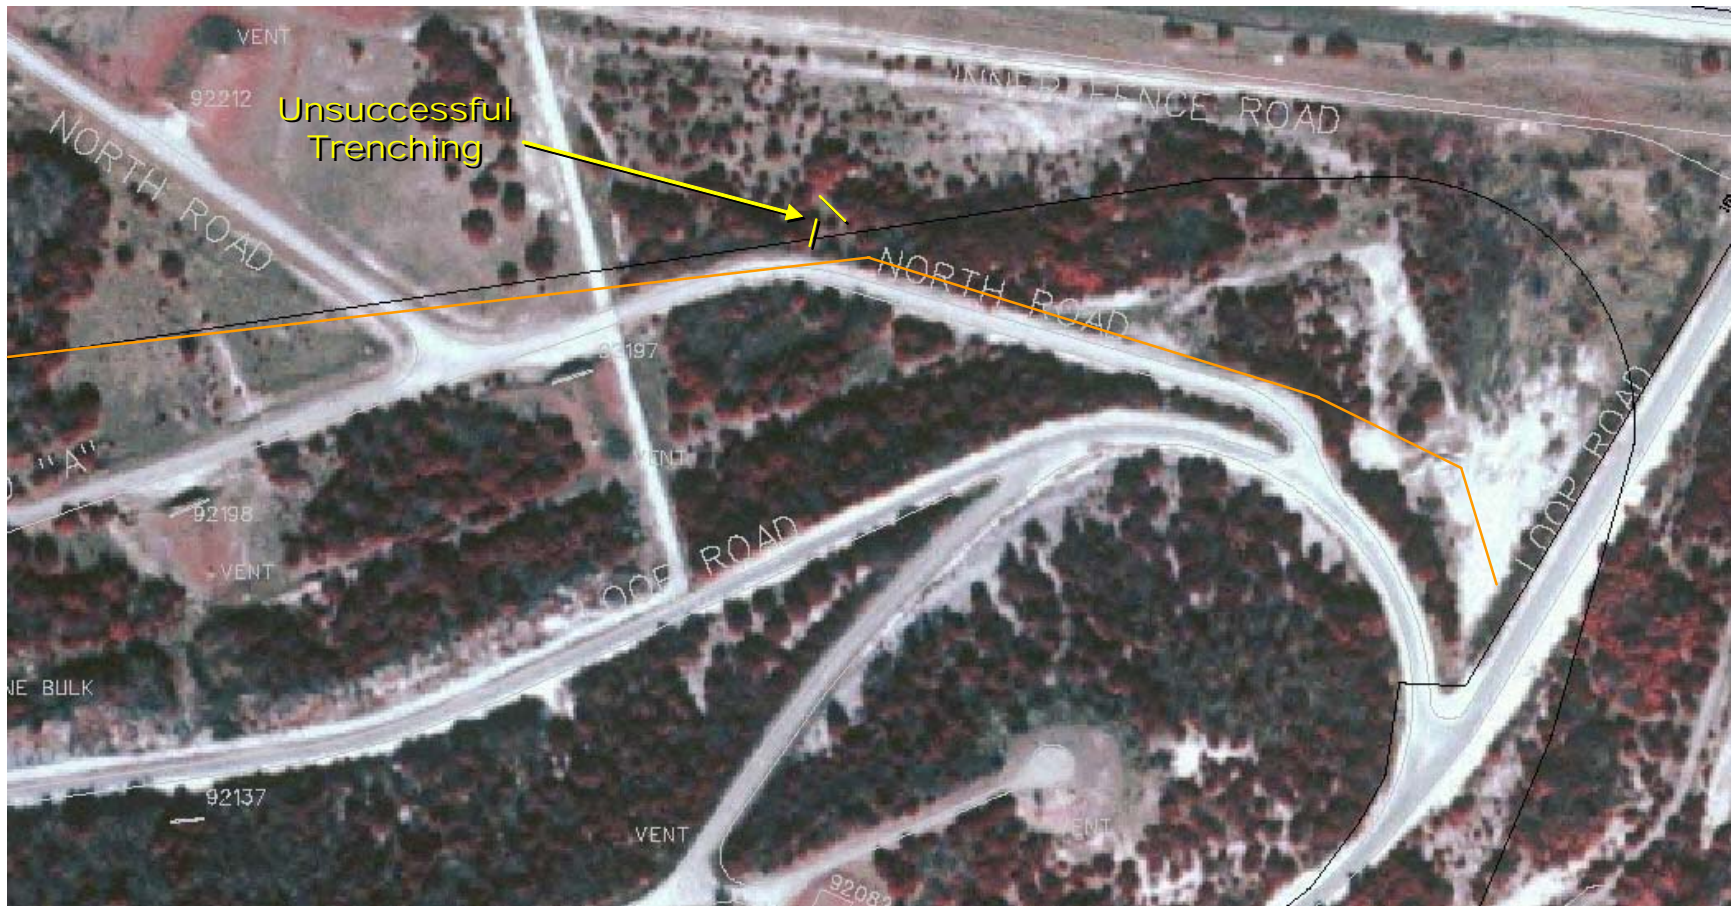
Figure 6. Showing an example of how the actual pipeline route (orange line) is different from the GIS map indicated route (black line).

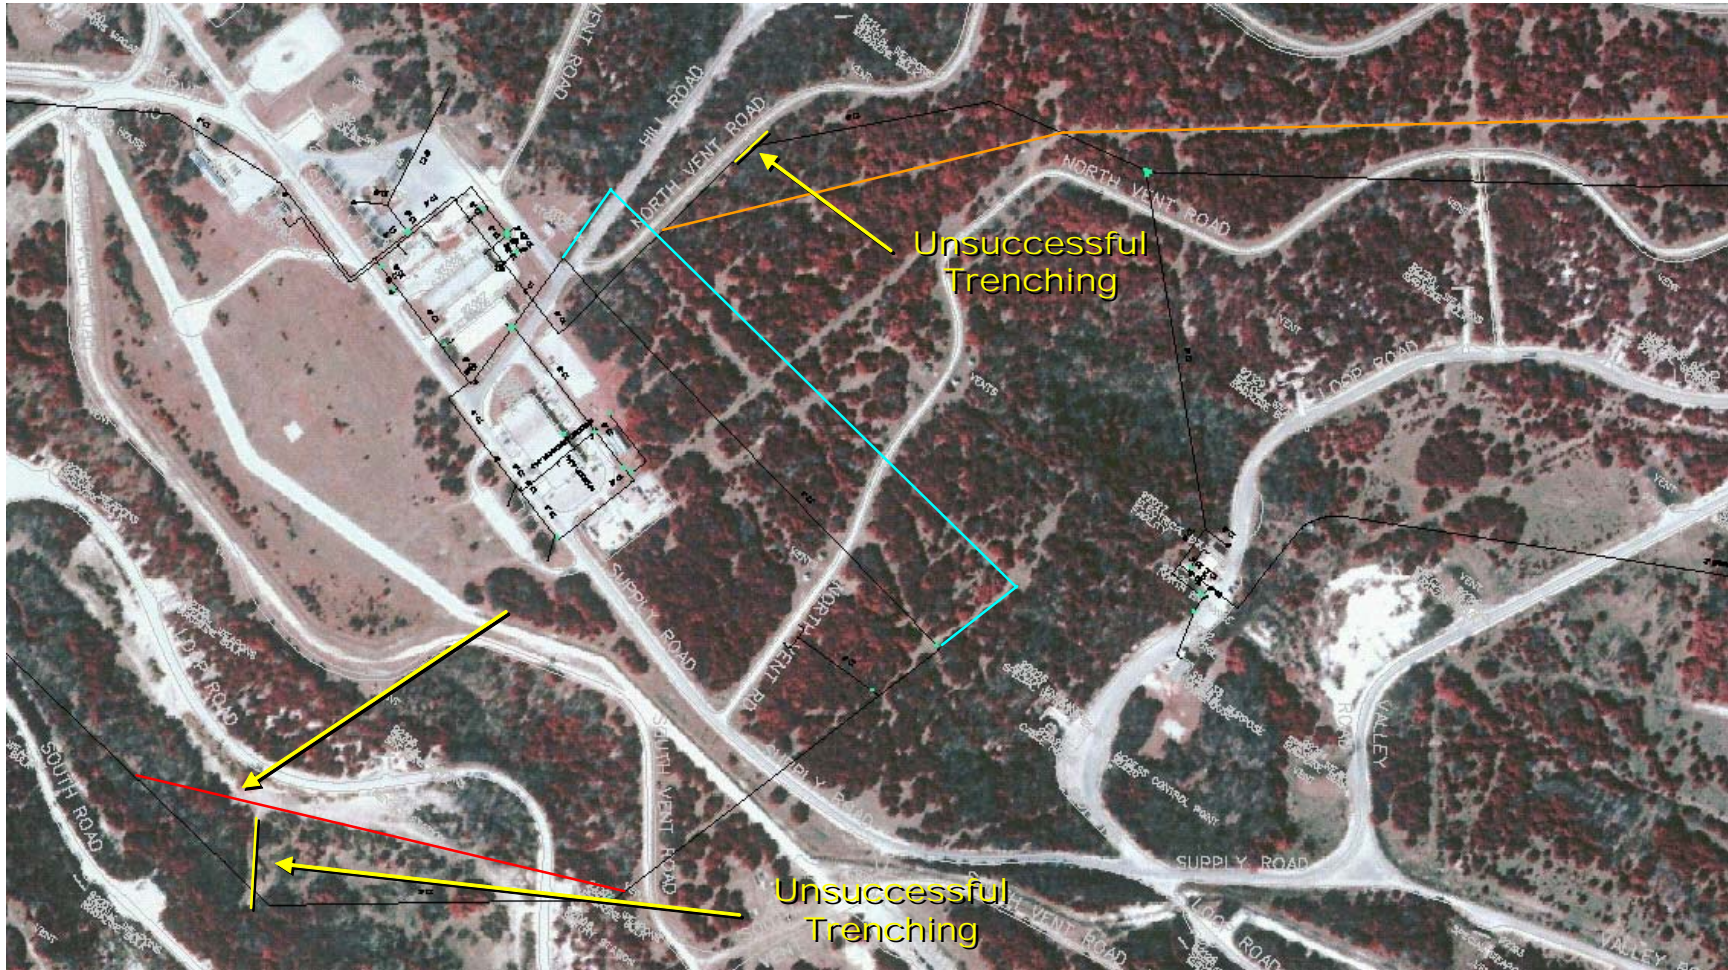
Figure 7. Showing another example of how actual pipeline routes (red, light blue, and orange lines) are different from the GIS map indicated route (black line).

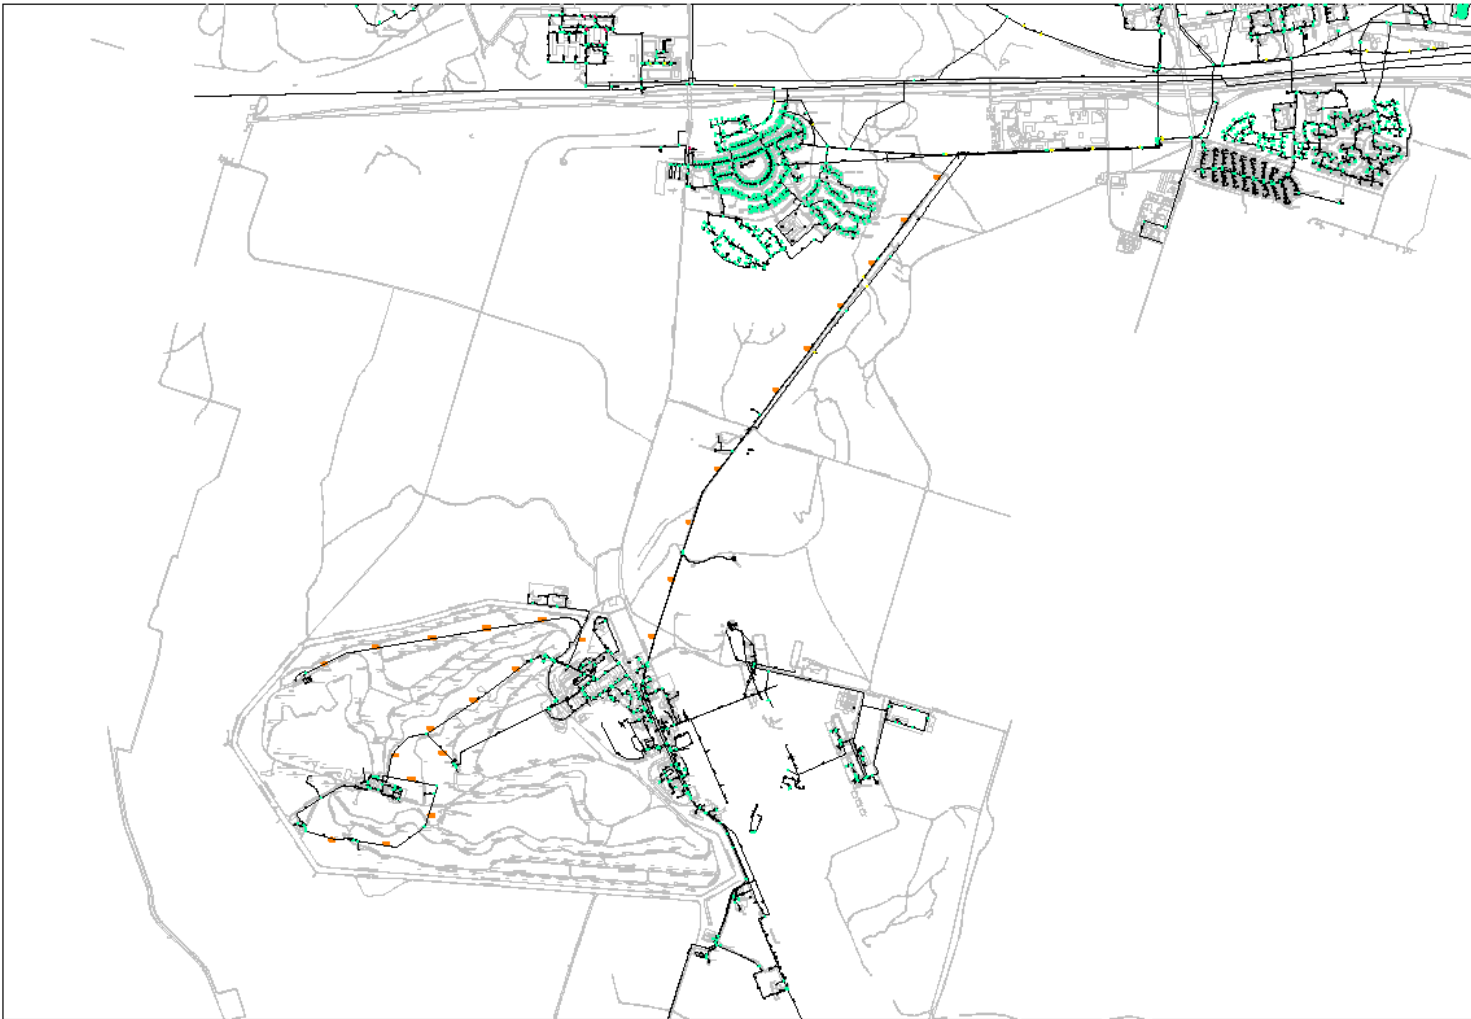
Figure A1. An overall view of all 25 leak sensors in West Fort Hood.

The following maps show the positions of all 25 PermaLog leak sensors installed at West Fort Hood during the project. The maps start with a broad overall view of the entire leak sensor layout, shown in Figure A1. Then three broad views of about one-third of the system per view are shown in Figures A2 – A4. Finally, six close-up views of about one-tenth of the system per view are shown in Figures A5 – A10.

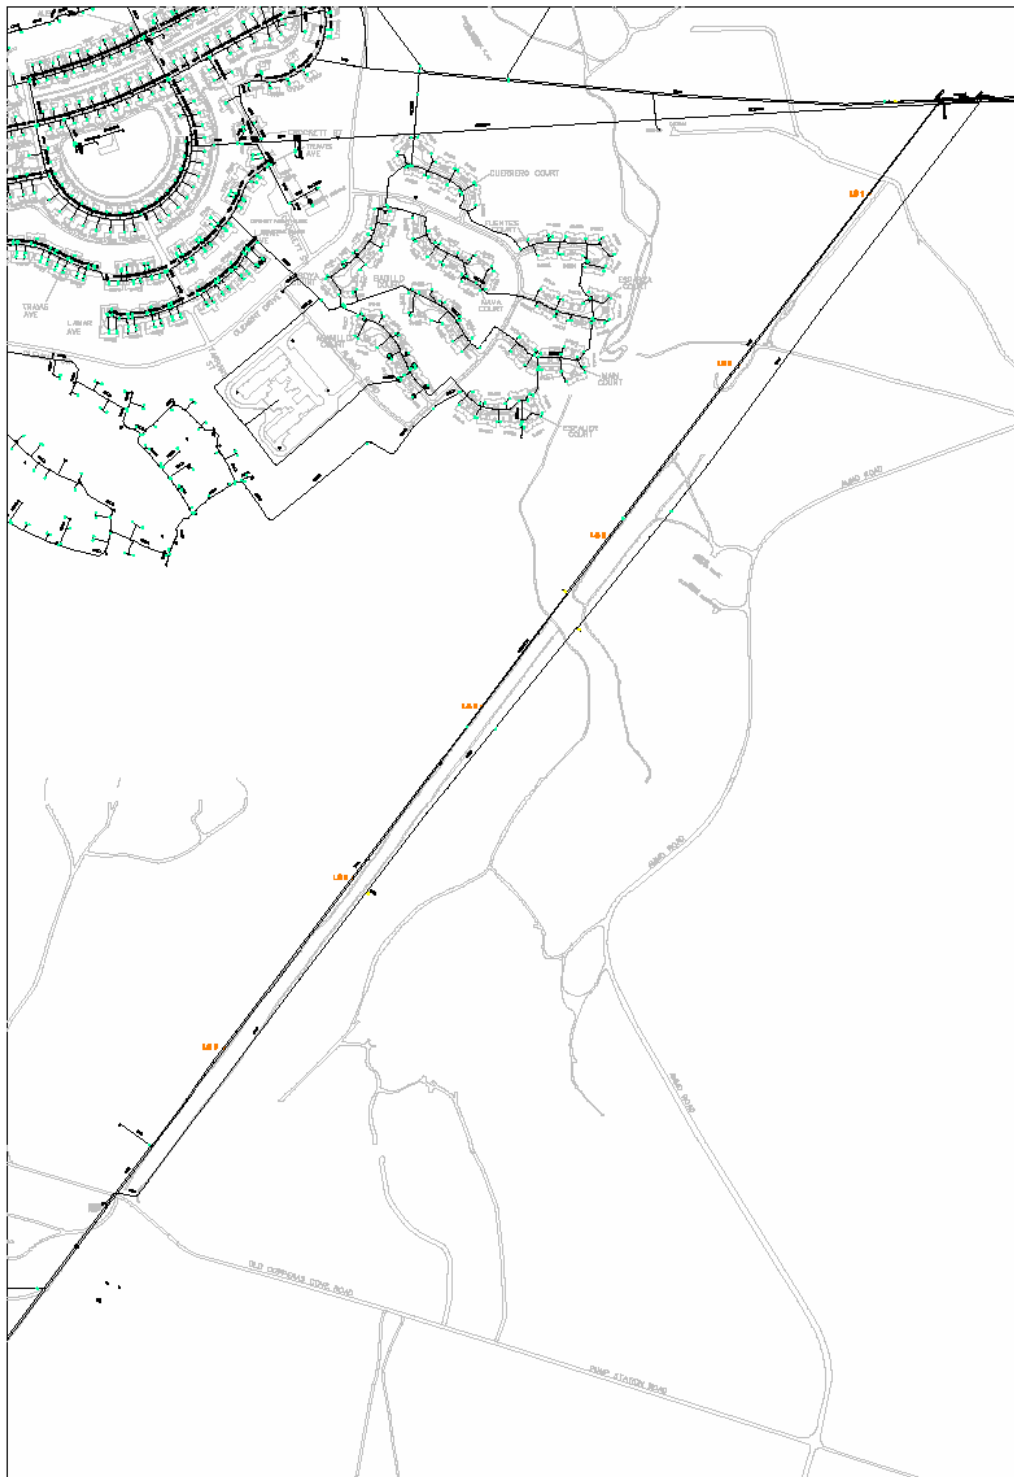
Figure A2. A broad view of leak sensors 1 – 6 in West Fort Hood.
